EFFECT OF THE QUENCHING IN WATER OF THE CEMENTITIOUS MATERIALS SUBJECTED TO FIRE

IBRAHIM MESSAOUDENE ^(1,3), LAURENT MOLEZ ⁽²⁾, RAOUL JAUBERTHIE ⁽²⁾, OUSSAMA KESSAL ⁽³⁾, LAHCENE SLAMA ⁽³⁾

KEYWORDS: Cementitious materials, wood fire, quenching in water.

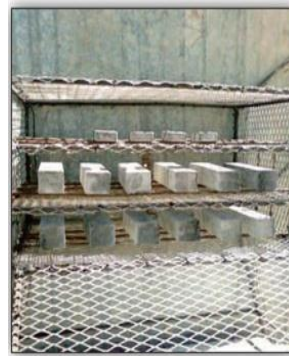
Figure 1: The arrangement of the test body

To simulate a real fire, we proceeded to fabricating a device which ensures a homogeneous distribution of fire on all samples of cement pastes and mortar (see Fig. 1). The device in the form of a cage is composed of high temperatures resistant steel rods. It consists of three superimposed rooms separated by grids to facilitate the dissemination of heat through the test body. The device is instrumented with thermocouples.

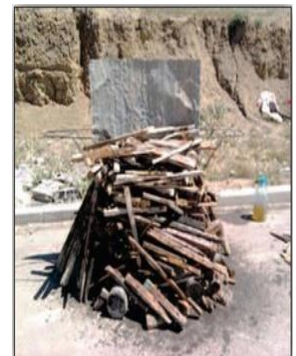
Figure 2: Test body covered with wood

The body's tests are covered by wood. The fire is lit on a bed of gasoil (see Figs. 2 and 3). The wood is added in a regular way to maintain the fire for one hour. This choice is guided by fire conditions and emergency intervention. The test is conducted in the open-air in spring weather at a temperature of 23°C and a moderate wind from the

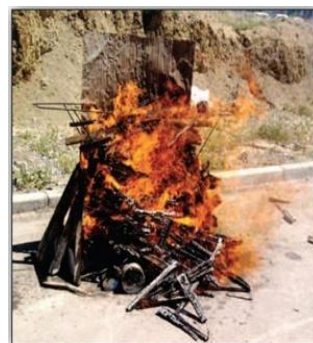
Figure 3: Test fire

The flame and the surface of the body's test temperature is recorded every 10 min. At the end of the test, the flame has reached 700°C and 410°C for the surface of the test body. The fire is allowed to turn in air.

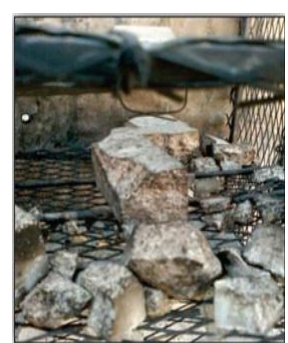
Figure 4: Burst test bodies

The fire resulted the bursting of test body (Fig. 4). However, four specimens and two pastes have kept their good form and are subject to two types of cooling before to be tested: cooling at ambient air and sudden quenching in water.

The bursting of test body is explained by rapid heating of its surfaces. Rapid heating causes thermal stresses, from the high thermal gradients that create compressive stresses and tension in the structure. Khoury (3) considers that these constraints have a key role to play in instabilities due to the geometry of the material. Kanema Tshimanga (4) shown that the phenomenon of bursting happens for surface temperature between 300 and 350°C (in our case 410°C).
